# Bathymetric and Velocimetric Surveys at Highway Bridges Crossing the Missouri and Mississippi Rivers on the Periphery of Missouri, July–August 2018

By Richard J. Huizinga

Scientific Investigations Report 2020–5088

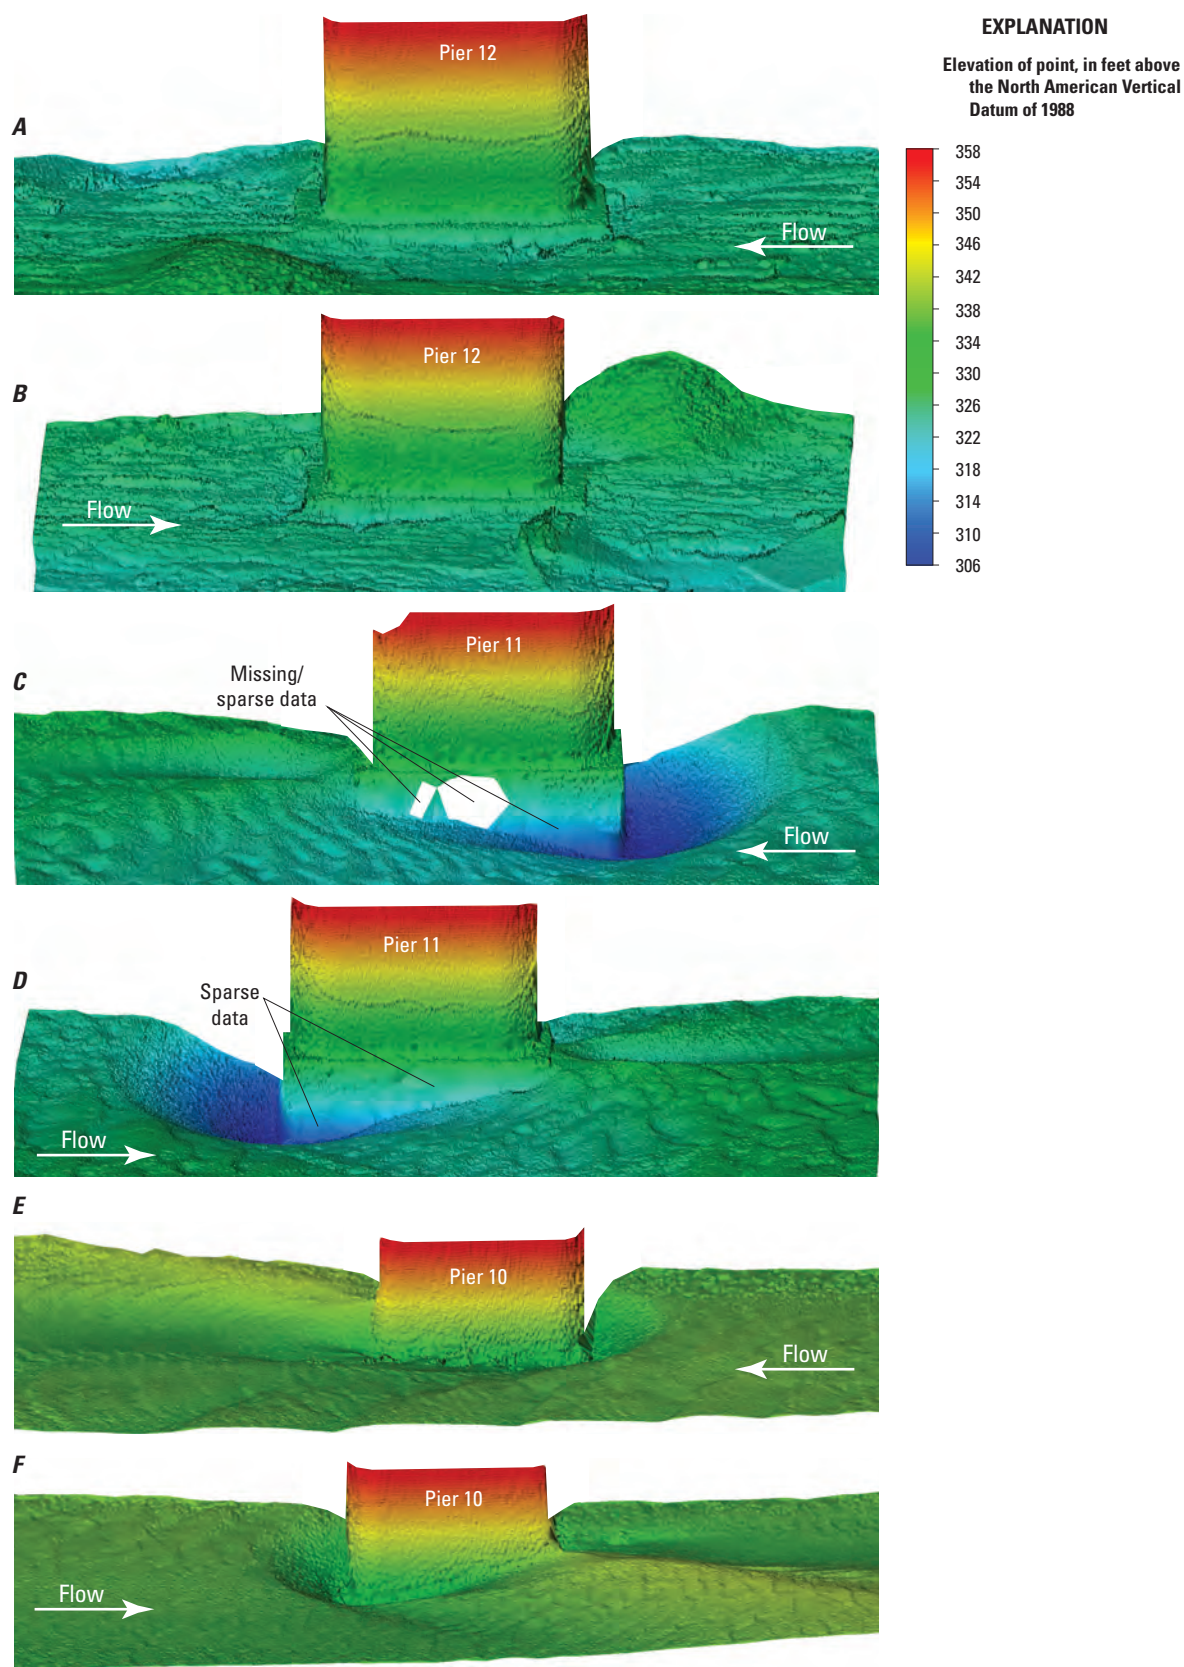
Near pier 11 (fig. 23), a substantial scour hole had a minimum channel-bed elevation of about 306 ft (table 7), which is about 16 ft below the average channel elevation upstream from the pier (figs. 23, 25, 1.5C, 1.5D). Information from bridge plans (Missouri Department of Transportation, written commun., 2000) indicates that pier 11 is founded on a caisson on bedrock, having about 40 ft of bed material between the bottom of the scour hole and bedrock (fig. 25; table 7). Near pier 10 (fig. 23), a moderate scour hole had a minimum channel-bed elevation of about 330 ft (table 7), which is about 8 ft below the average channel elevation upstream from the pier (figs. 23, 25, 1.5E, 1.5F). Pier 10 also is founded on a caisson on bedrock, having about 85 ft of bed material between the bottom of the scour hole and bedrock (fig. 25; table 7). Pier 12 is founded on footings on the exposed bedrock on the right bank, with no apparent scour hole nearby (figs. 23, 25, 1.5A, 1.5B; table 7). Pier 13 also is founded on footings on the exposed bedrock on the right bank, and was near the surveyed water surface with no apparent scour hole nearby (figs. 23, 25; table 7). In modern construction, bridge substructural elements usually are pinned or socketed to bedrock (American Association of State Highway Transportation Officials, 2012; Brown and others, 2010), but full exposure of usually buried substructural elements warrants special consideration and

**Figure 1.5.** Shaded triangulated irregular network visualization of the channel bed and main channel piers of structure L0135 on State Highway 51 over the Mississippi River at Chester, Illinois. *A*, left (northeast) side of pier 12. *B*, right (southwest) side of pier 12. *C*, left (northeast) side of pier 11. *D*, right (southwest) side of pier 11. *E*, left (northeast) side of pier 10. *F*, right (southwest) side of pier 10.

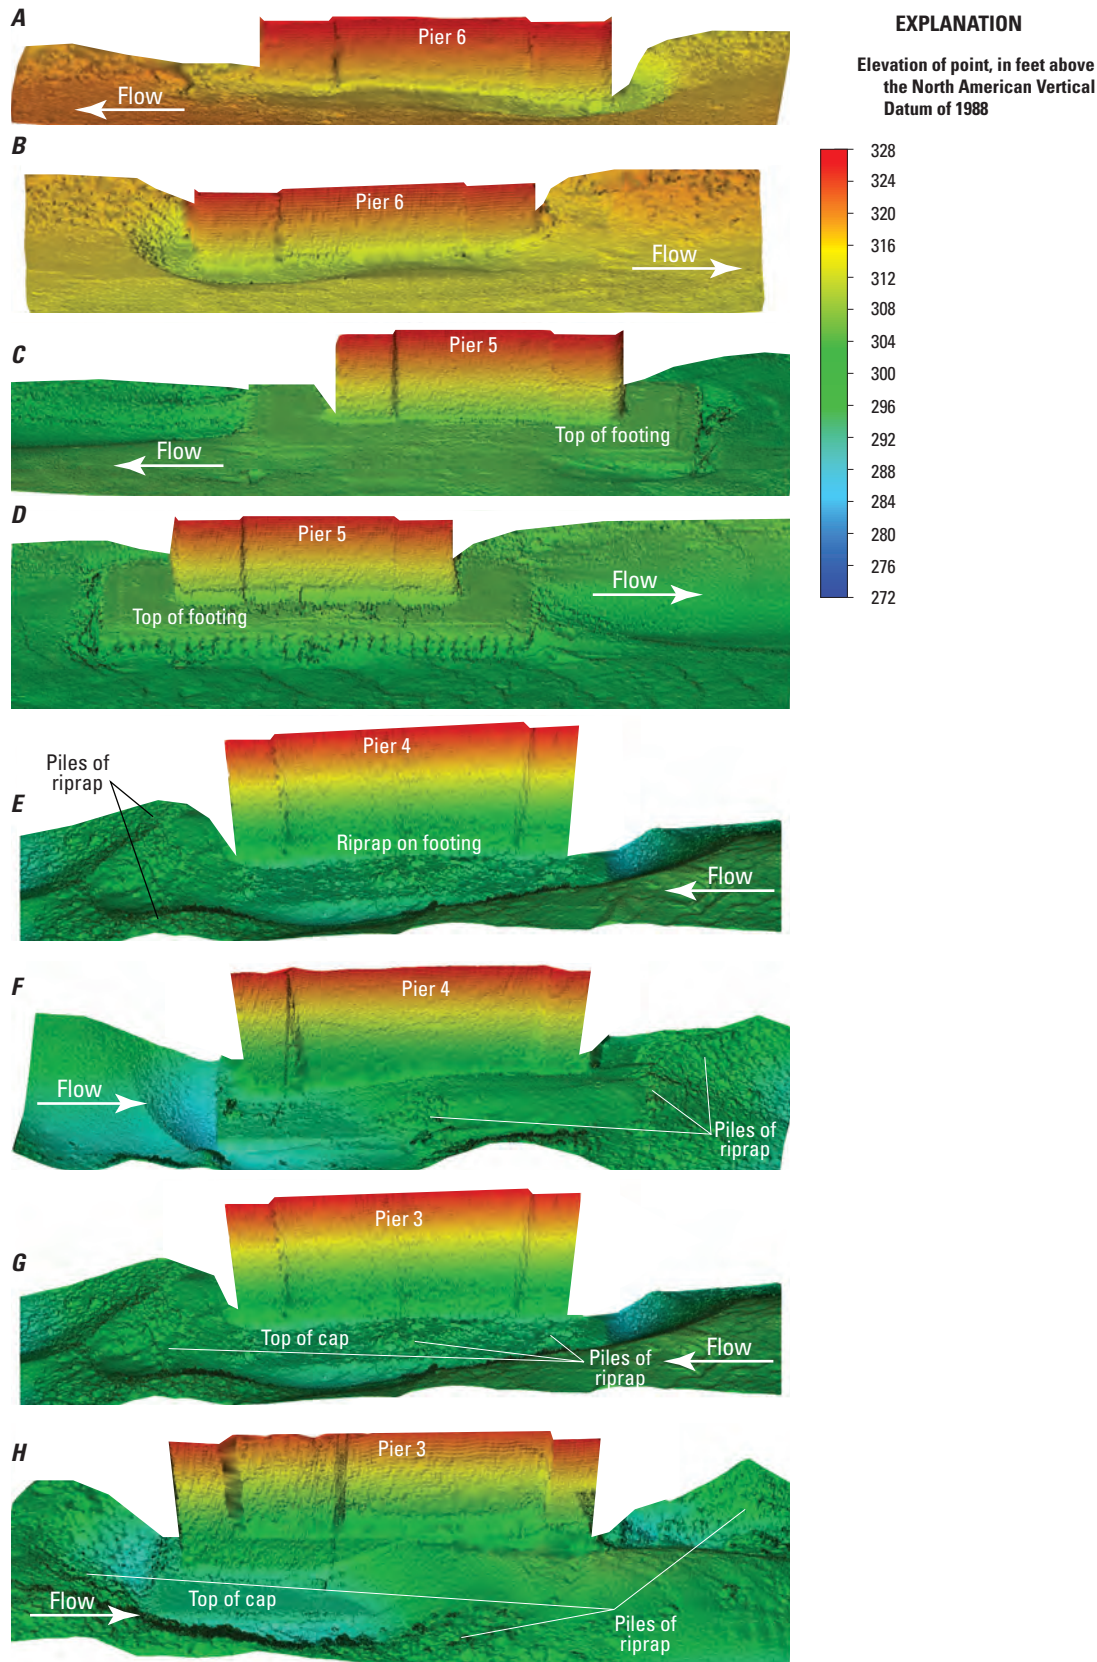
Piers 3 and 4 seemed to be partially surrounded by piles of riprap or rock (figs. 28, 1.6E through 1.6H), with additional scour downstream from the piers reaching a minimum elevation of 270 ft near pier 3 and 285 near pier 4 (fig. 28; table 7). Poorly defined, minor scour holes were observed near piers 5 and 6 (figs. 28, 1.6A through 1.6D), having a minimum channel-bed elevation of about 300 ft at pier 5 and 311 ft at pier 6 (table 7); however, the top of the footing was visible at pier 5, and the top of the distribution cap was visible at piers 3 and 4 (figs. 28, 30). The minimum channel-bed elevation near pier 5 is about 15 ft above the elevation of the bottom of the pier seal course of 285.00 ft, and the minimum channel-bed elevation near pier 6 is about 19 ft above the elevation of the bottom of the pier seal course of 292.00 ft (fig. 30; table 7). Information from bridge plans (Missouri Department of Transportation, written commun., 2014) indicates that piers 3 and 4 are founded on caissons on bedrock, having about 20 ft of bed material between the bottom of the scour hole and bedrock at pier 3, and 41 ft of material at pier 4. Piers 5 through 7 are founded on shafts drilled as much as 22 ft into bedrock, having about 55 ft of bed material between the bottom of the scour hole and bedrock at pier 5, and about 66 ft of material at pier 6 (fig. 30; table 7). The surveyed bed generally was similar to the previous survey in 2014, and the original ground line in 1996 from bridge plans, except near pier 4 (fig. 30).

**Figure 1.6.** Shaded triangulated irregular network visualization of the channel bed and main channel piers of structure A5076 on State Highway 34 over the Mississippi River at Cape Girardeau, Missouri. *A*, left (east) side of pier 6. *B*, right (west) side of pier 6. *C*, left (east) side of pier 5. *D*, right (west) side of pier 5. *E*, left (east) side of pier 4. *F*, right (west) side of pier 4. *G*, left (east) side of pier 3. *H*, right (west) side of pier 3.

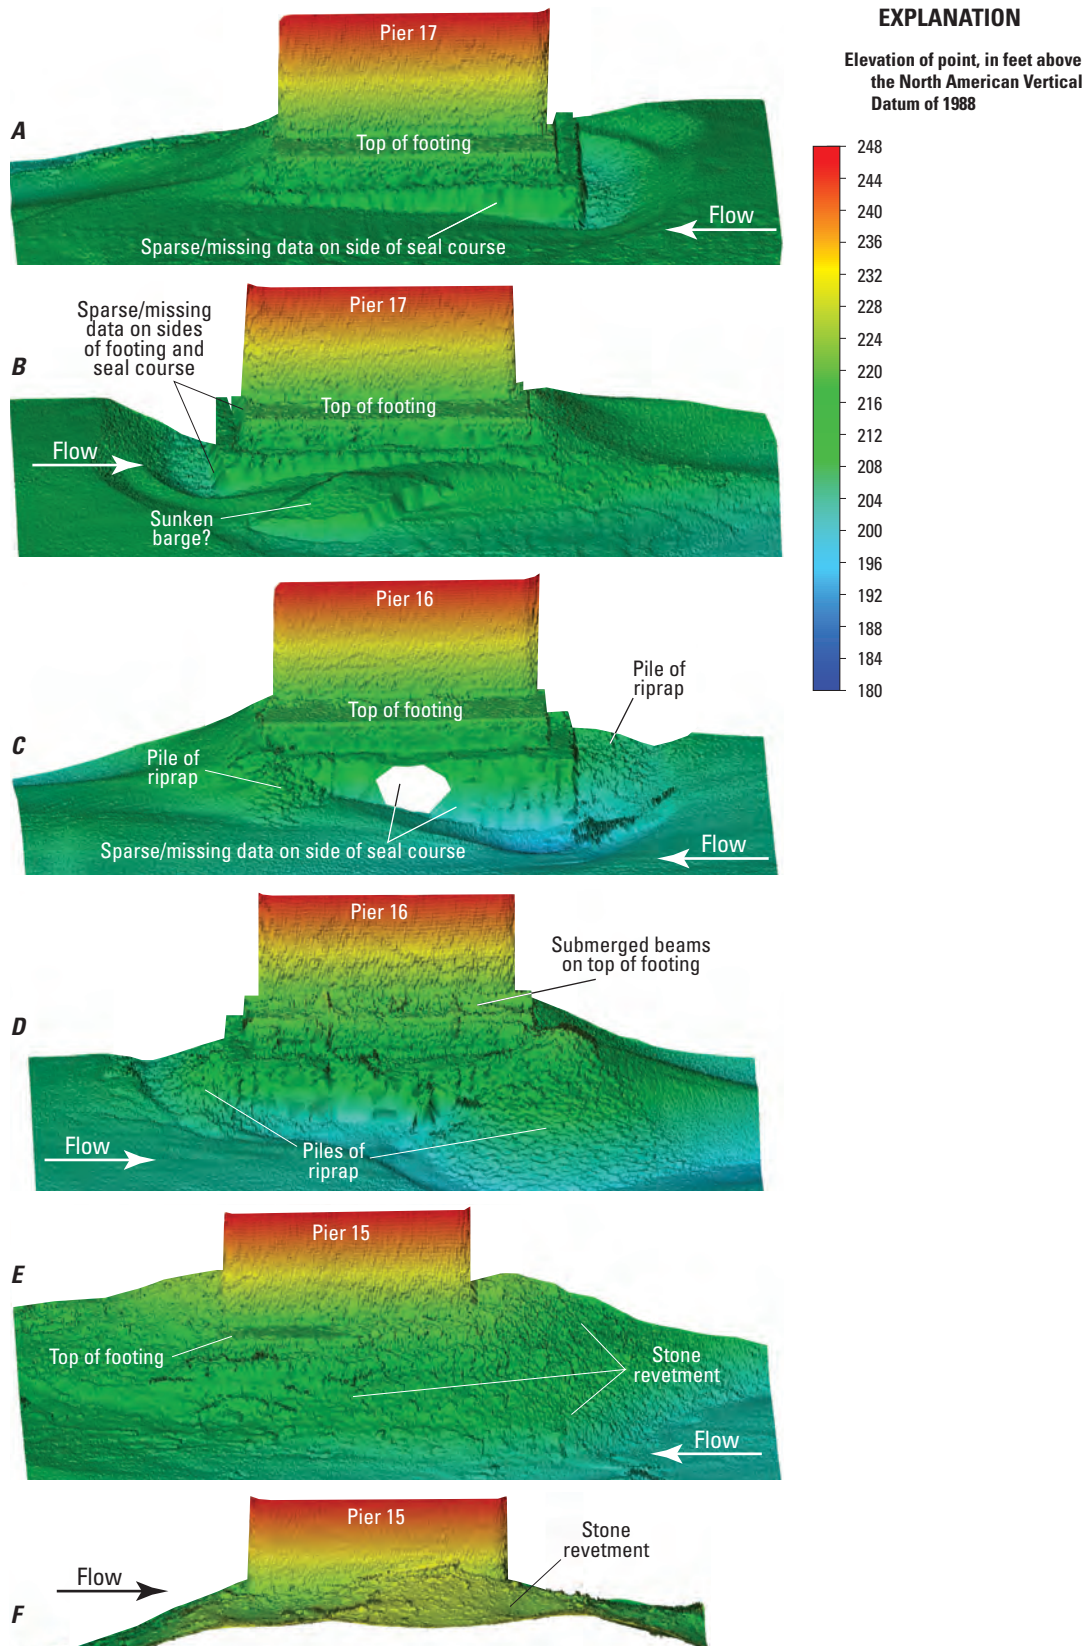
into flow. The cross section along the upstream bridge face (fig. 35) shows a localized high bed elevation near the left edge of the riprap blanket at pier 20 that coincides with the observed object. Pier 15 is embedded in the stone revetment along the right bank (figs. 33, 35, 1.8E, 1.8F), and pier 16 seems to be surrounded by several almost random piles of riprap, which may help mitigate scour (figs. 33, 35, 1.8C, 1.8D).

**Figure 1.8.** Shaded triangulated irregular network visualization of the channel bed and main channel piers of structure A1700 on Interstate 155 over the Mississippi River near Caruthersville, Missouri. *A*, left (southeast) side of pier 17. *B*, right (northwest) side of pier 17. *C*, left (southeast) side of pier 16. *D*, right (northwest) side of pier 16. *E*, left (southeast) side of pier 15. *F*, right (northwest) side of pier 15.
